Appendix I

Lisa Pocock, database manager, Yarra Yarra Catchment Management Group, Kalannie

Ecological Assessment of the Yarra Yarra Catchment

Deep Drainage
Assessment
Monitoring Report

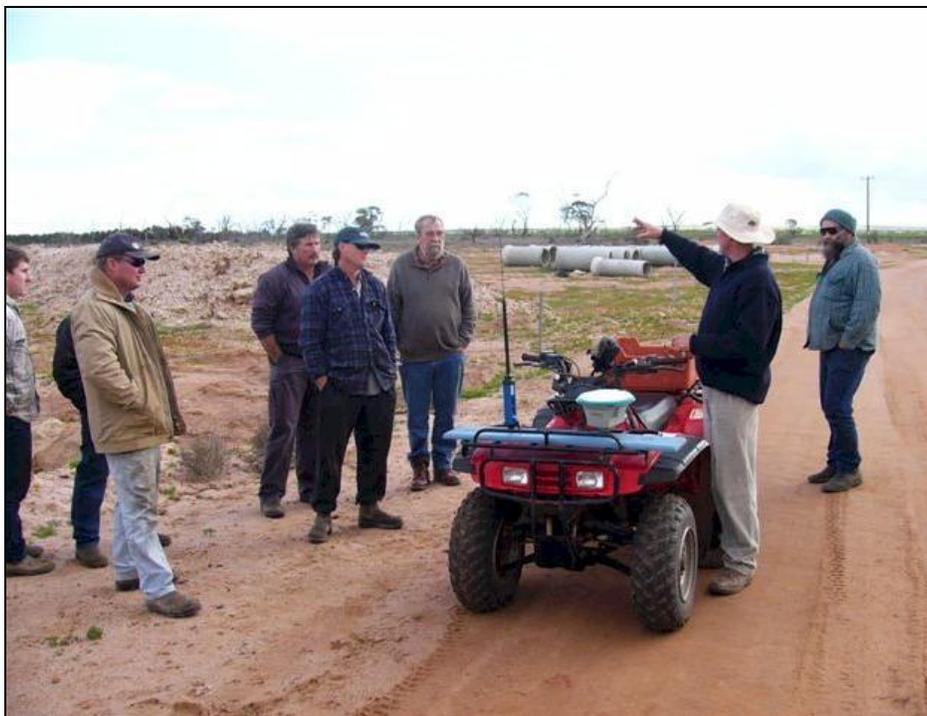
Fig. 3. Four-wheel bike set up as a rover with RTK survey equipment. Explaining to local farmers how and why we are doing the survey.

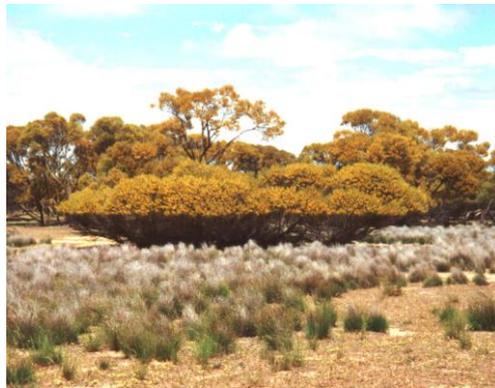
Stock access to remnant vegetation causes extensive damage, primarily through grazing and trampling of the understorey and regenerating seedlings. Larger shrubs and trees are less prone to direct damage in comparison to seedling, although ringbarking and root trampling can cause severe damage in heavy grazing. Stock grazing was also found to cause the introduction of weeds and erosion associated with trampling (Orsini, 1996).

Photo 7 : Effect of stock grazing remnant vegetation..

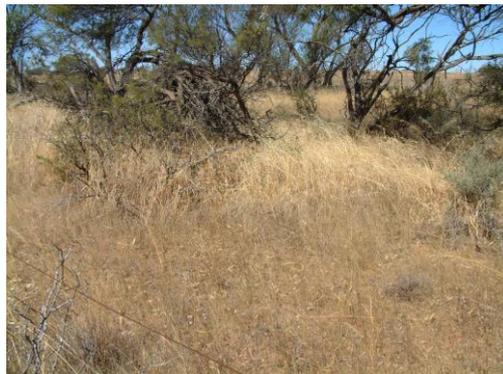
Grassy weeds compete with native understorey species and outcompete natives as they rapidly establish in the understorey due to degradation by stock of natural vegetation. Grassy weeds generally enter remnants from pastures.

Photo 8 : Grassy weeds present in a remnant adjacent to pasture.

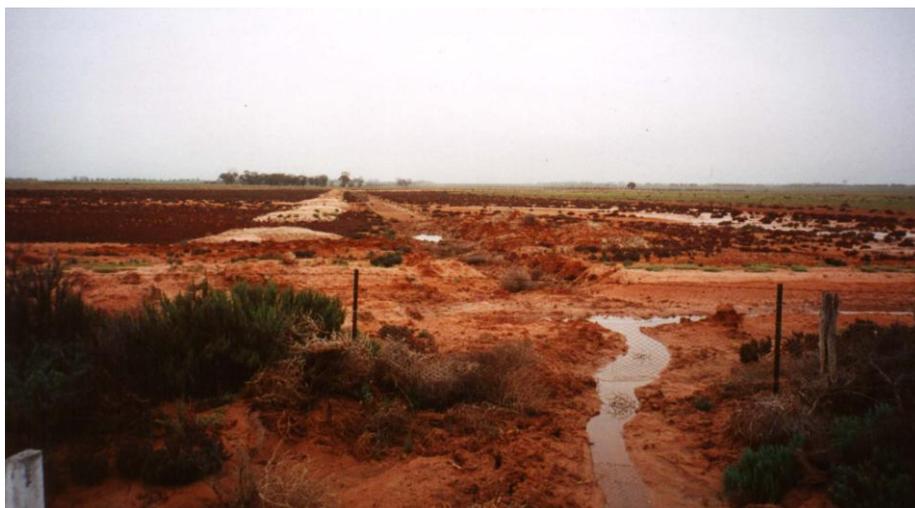
Photo 9: An example of drainage in the Goodlands Sub catchment

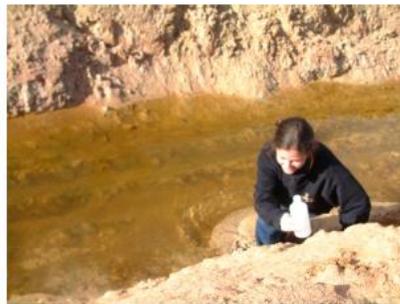
Estimates of the discharge volumes from the drains were calculated by recording the flow rates. Flow rates were estimated by timing and measuring the distance traveled by a cork down the drain and calculating a cross sectional area of the drain.

Photo: Collecting water samples from deep drain in Burakin.

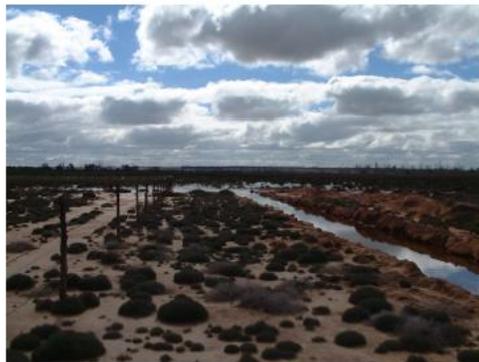
This 11ha represents less than 4% of the primary receiving wetland and after 3 years of the wetland receiving discharge from the drain there has been no increase in the area of the zone of influence from the drain. This indicates that the water flowing into the wetland is being discharged; most likely via evaporation at the same rate (if not faster than) it is moving into the wetland. This being the case it is reasonable to conclude that if water continues to enter the wetland system at the same rate the impact of the additional water on the wetland will be minimal.

*Photo: End of
Youangarra Drain
(Primary receiving
wetland)*

The samphire vegetation within the zone of influence appears to be greener than elsewhere in the wetland however without any tissue analysis of the vegetation it is not possible to determine if this is due to a luxurious uptake of water or nutrients. There appears to be a decreasing gradient of total nitrogen in the soils (See Table 2) from the drain end to outside the zone of influence. A more detailed study of the uptake of nitrogen by samphire is necessary to draw any conclusions as to the effect this gradient may be having on the vegetation.
