Final Report of the Yarra Yarra Regional Drainage and Research Project

Produced by the Yarra Yarra Catchment Management Group

The Yarra Yarra Regional Drainage Program Final Report Stage 1

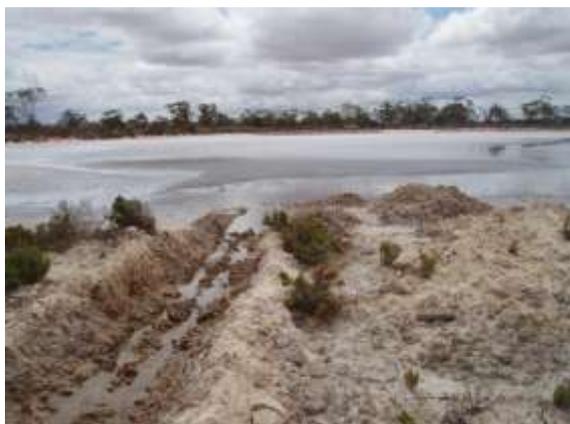
Fig 1: 15 Hectare Lake (Mongers 55)

This 15 hectare playa lake has been receiving ground water with a pH of around 3.5 from 10 km of deep drains for the last 4 years at an average rate of about 800 kl per day. There has been no visible damage to the site over this time. The evaporation rate has been keeping pace with the inflow.

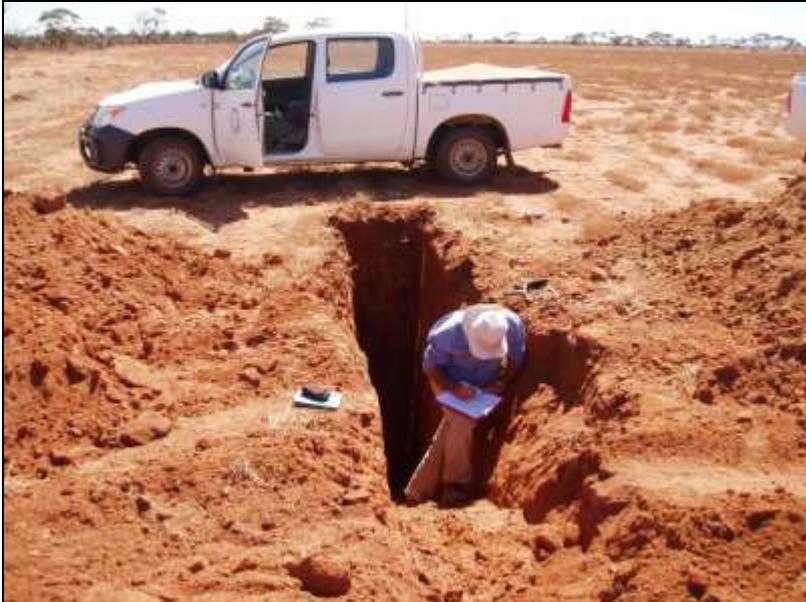
Fig 8: Carrying out soil sampling in a backhoe pit, Canna Gutha

Soil pits are established at regular intervals (around 1.5 km) along a potential drainage line to establish the structure of the soil profile, the rate of inflow of ground water and the quality of this water. These pits are usually around 3 metres deep. The YYCMG employ a full time soil scientist to undertake these assessments as well as to oversee the monitoring program.

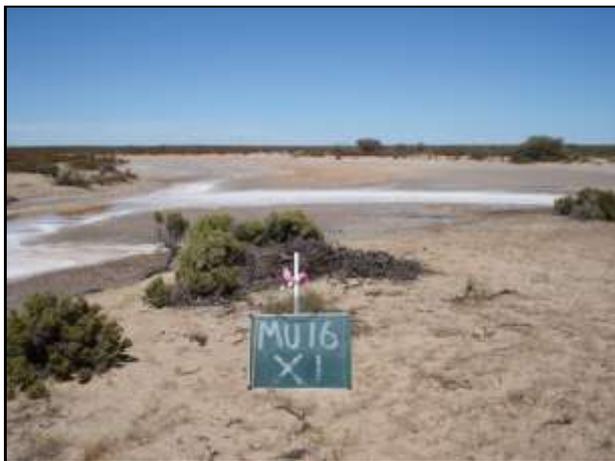
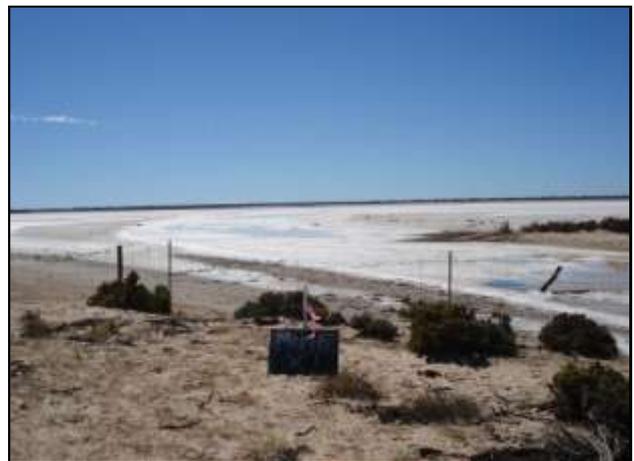
Fig 9a: Photoreference point, Mongers 16 looking upstream

Figs 9a and 9b depict a single photoreference point. Fig 9a is looking “upstream” and Fig 9b is taken from the same area looking out across the lake. The Mongers 16 drain water will eventually discharge here. The stake will allow us to take photos from exactly the same spot every 12 months. We can then monitor any effects that the drain has on the discharge area.

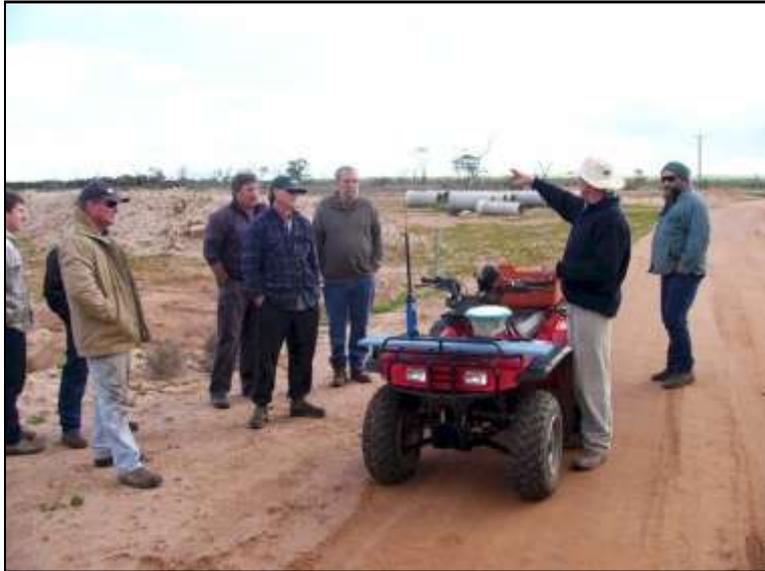
Quad bike with mounted RTK equipment. The equipment includes a remote base station which is not shown here.

Fig 11: The RTK surveying set-up, Burakin

The YYCMG have a qualified surveyor as a permanent staff member who is trained in the use of Real Time Kinematic (RTK) surveying equipment. The YYCMG have purchased one of these instruments (at a cost of \$47,000) to enable us to survey with extreme accuracy (within 2cm in height AHD). Data taken at 25m intervals can be downloaded onto a map, as shown above.

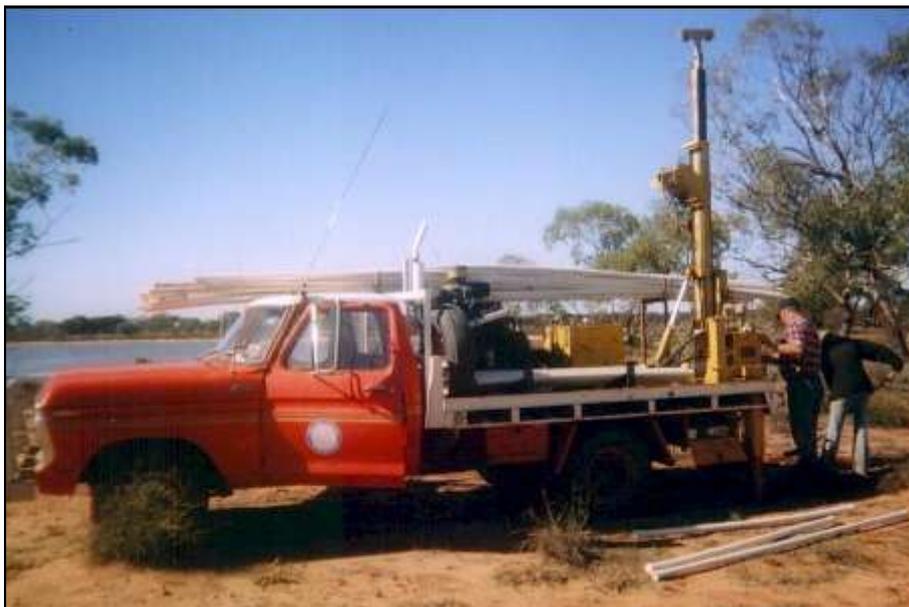
Fig 14: The drill rig in action

Groundwater level is one of the main indicators used to ascertain the suitability of a drainage site. Boreholes are used to determine the level of the groundwater throughout the catchments. These bores are located roughly at intervals of 1.5 kilometres along the valley floor. The bores are drilled to an average depth of 4 metres, and are cased with poly-pipe see below (Fig 14).

The Yarra Yarra drill rig has been used extensively throughout the catchment management area. To date, over 1000 boreholes have been established, for the purpose of measuring and monitoring groundwater levels.

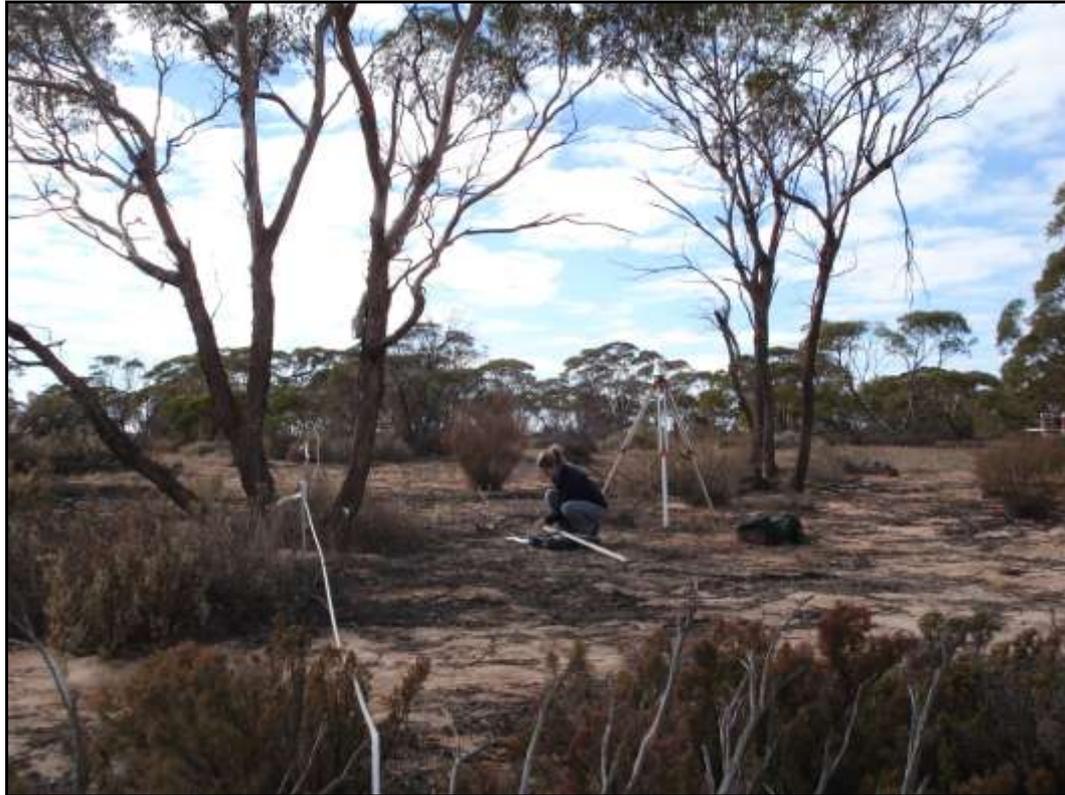
Fig 15: Vegetation transect, Bowgada

The transect shown above is one of the vegetation control sites in the Bowgada sub-catchment. These control sites are essential to obtain a comparison between the vegetation sites adjacent to the drain, compared with similar sites remote from the drain.

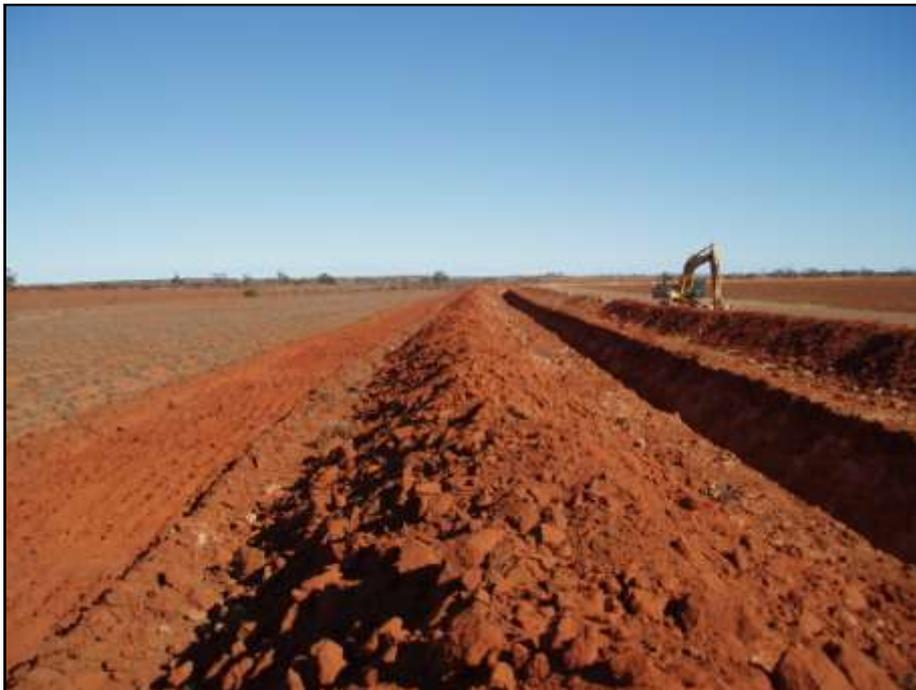
Fig 17: Taken at Canna Gutha. Surface water channels either side of the levee banks flanking the central deep groundwater drain.

The surface drains are 3 to 4 metres wide and 300mm to 400mm deep. We have found that it is prudent to establish the drain complex slightly higher than the lowest point in the valley floor, this gives the drain protection from extreme flood events.

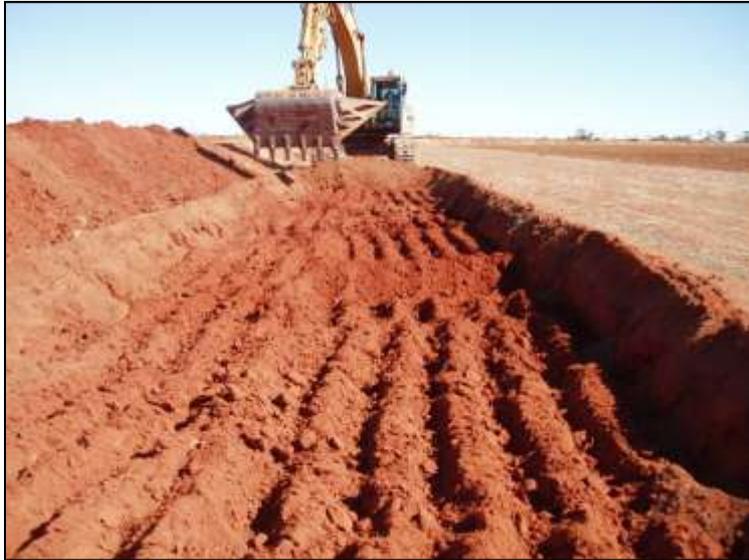
Notice the levee bank on the left hand side. Top soil excavated from the surface channel is deposited on the levee bank for two reasons.

Fig 18: Construction of the surface drain, taken at Canna Gutha

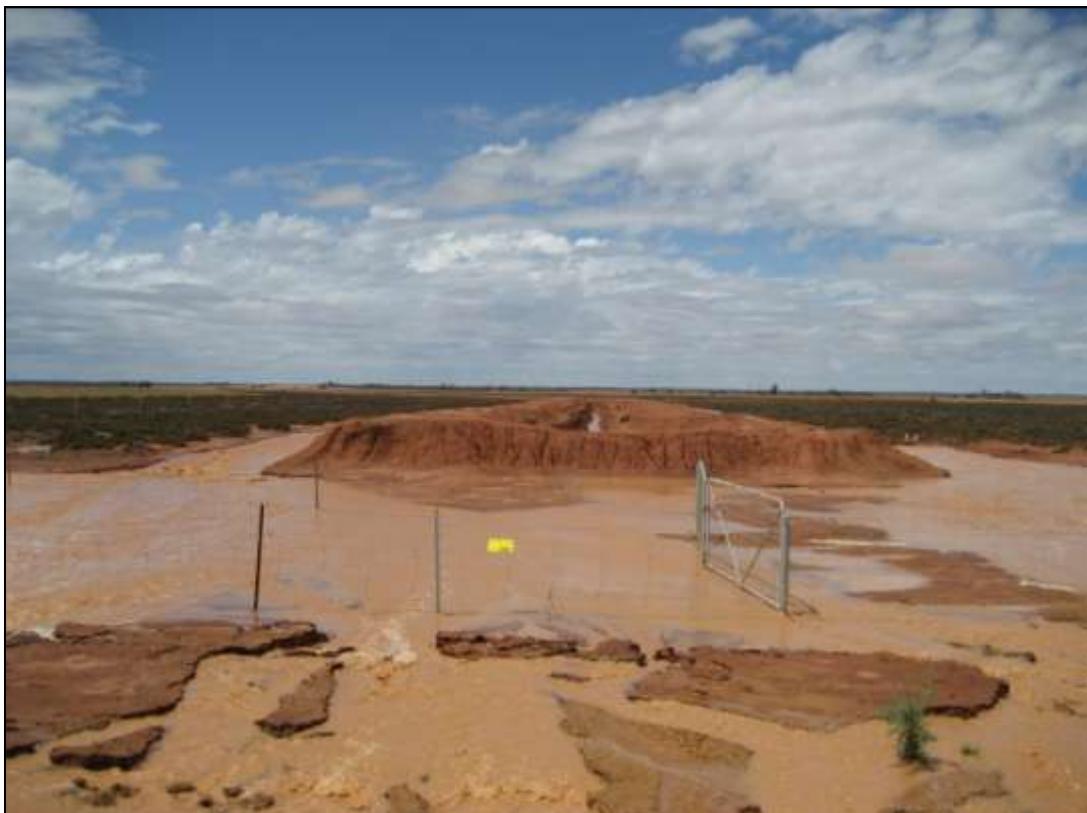
Fig 19: Putting the design to the test. Mongers 55 deep drain, standing up to a major flood event in February 2008. Notice that the surface water remains separated from the groundwater inside the drain.

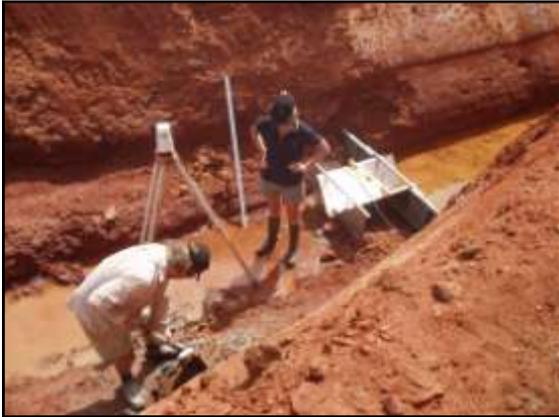
Fig 22a Constructing the flume at Merkanooka

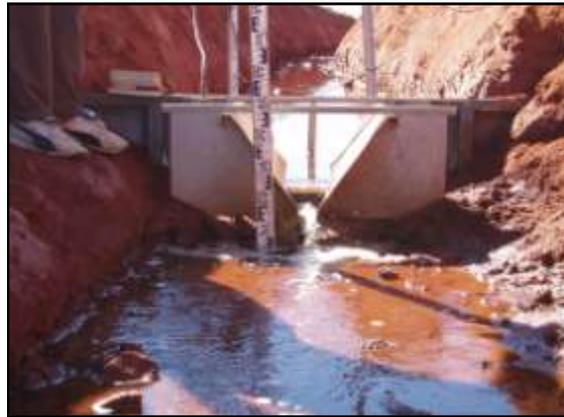
Fig 22b The finished flume

A cut-off plate prevents any water bypassing the flume and therefore directs all of the water to pass through the weir for measurement purposes. You can see the plate clearly on Fig 22b

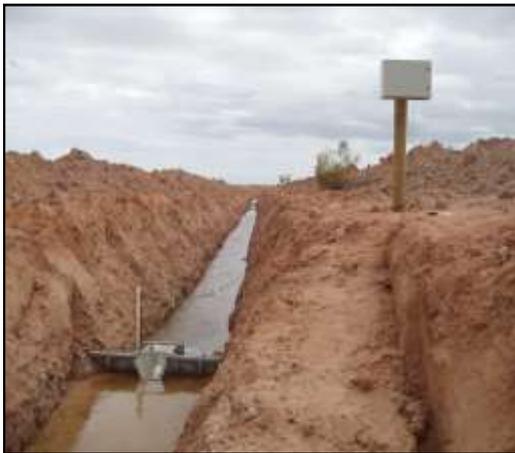
Fig 23a: Jibberding flume and monitoring station

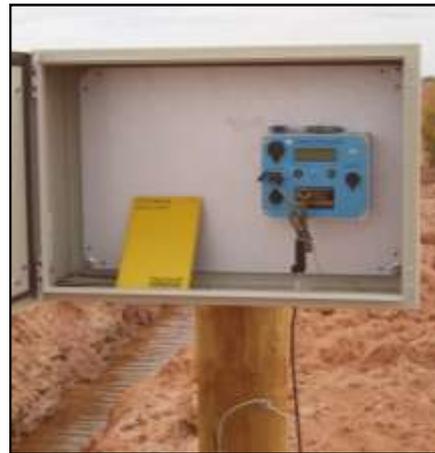
Fig 23b: A close up of the Jibberding monitoring station

All of these are logged directly into a monitor (the blue box, in Fig 23b) and stored for download at a later date (Fig 24). The monitor can store up to 3 years of data. All stations are powered by solar panels and can therefore be setup in remote sites to record data without the need for constant, costly field trips.

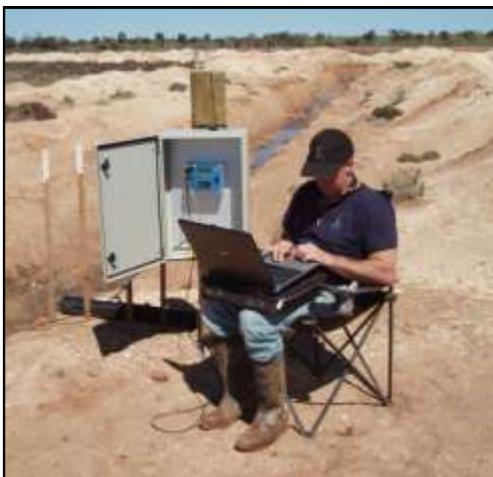
Fig 24: Downloading the data

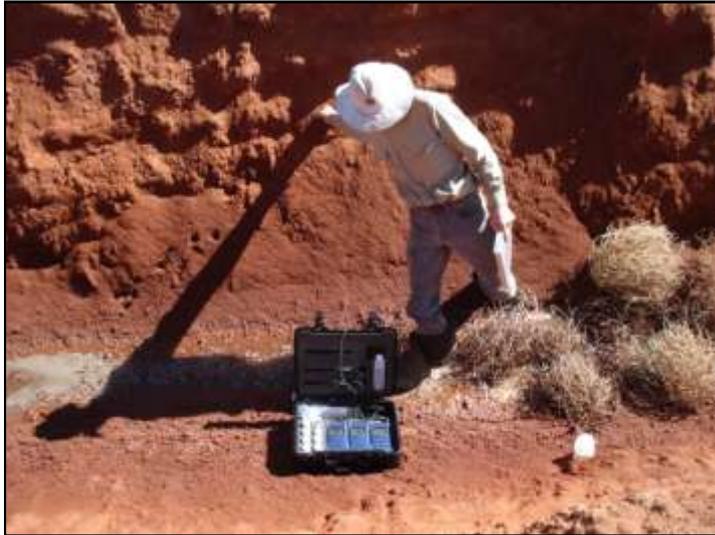
Whilst the flume and monitoring station are very useful, they are in a fixed location. This equipment shown in this photo enables us to check the pH, Eh and the EC of the drainwater at any location in the drainage network.

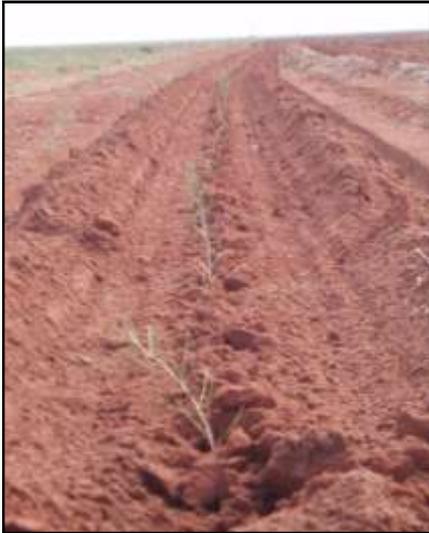
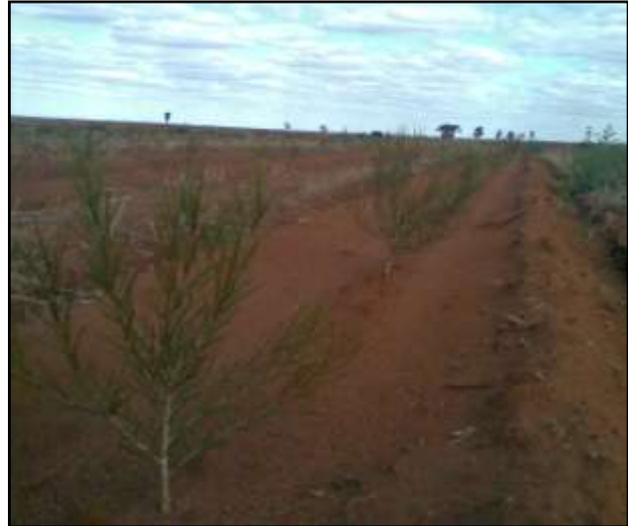
Fig 29: Broombush seedlings, August 2007

Fig 30: Broombush seedlings, May 2008

The two photographs above show the amount of growth over 10 months. When the seedlings were planted they were roughly 10cm tall, after 10 months they were about 50cm tall on average

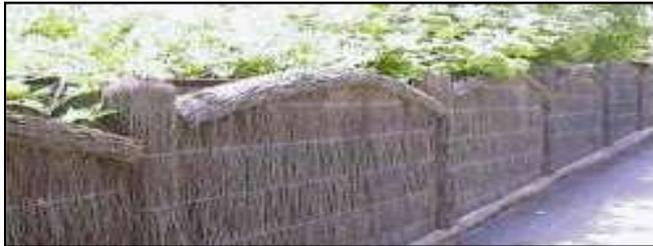
Fig 31: Brushwood fencing

Broombush can be harvested and used for making brushwood fences that are ornamental as well as providing shelter for nurseries and gardens. Currently the industry is quite buoyant and we hope that in 3 – 5 years time we may be able to start a rotational harvest of the Broombush, allowing us to generate income for further revegetation projects. As Broombush coppices, harvesting it will cause it to regrow more thickly than before, and creating a sustainable industry.

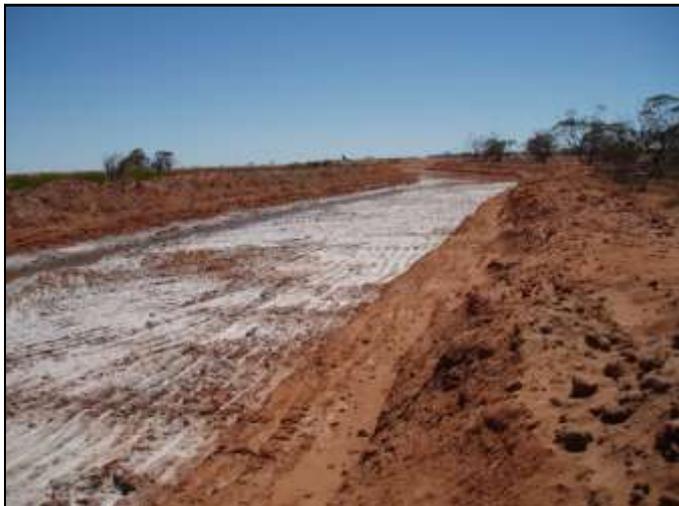
When the drain is “de-silted”, the silt is excavated and piled up into a bank alongside the channel. A layer of topsoil from the other side of this bank is then piled on top of the silt material. This helps to stabilise the bank and also provides a layer of good quality soil to encourage successful revegetation of the bank top and sides.

Fig 37: The Merkanooka surface water channel following de-silt.

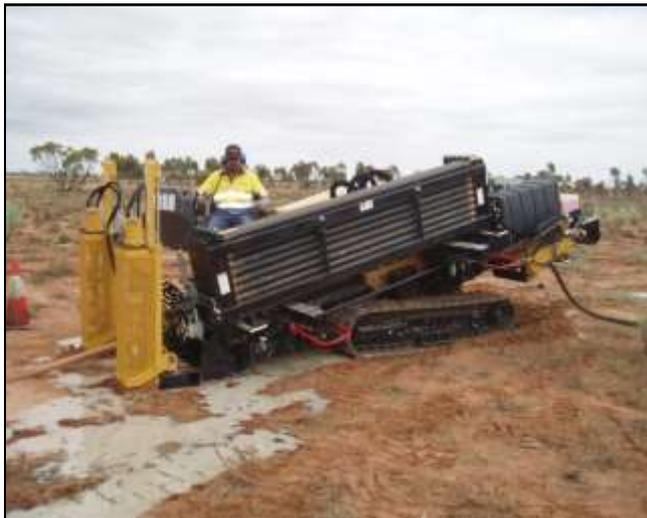
Horizontal line boring - Drilling under the Great Northern Highway 20km east of Wubin.

Fig 41: The horizontal line borer

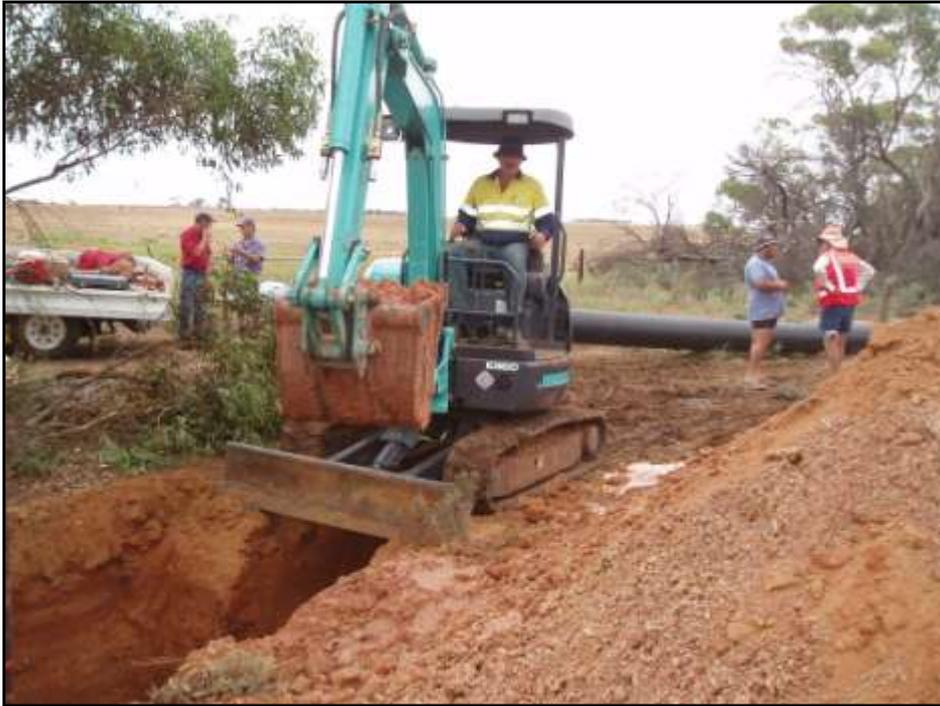
Digging the trench to expose the tunnel created by the horizontal line borer, which is 2.5 metres under the ground. This is in preparation for drawing the 36 metres of pipe under the highway. You can see the pipe in the background.

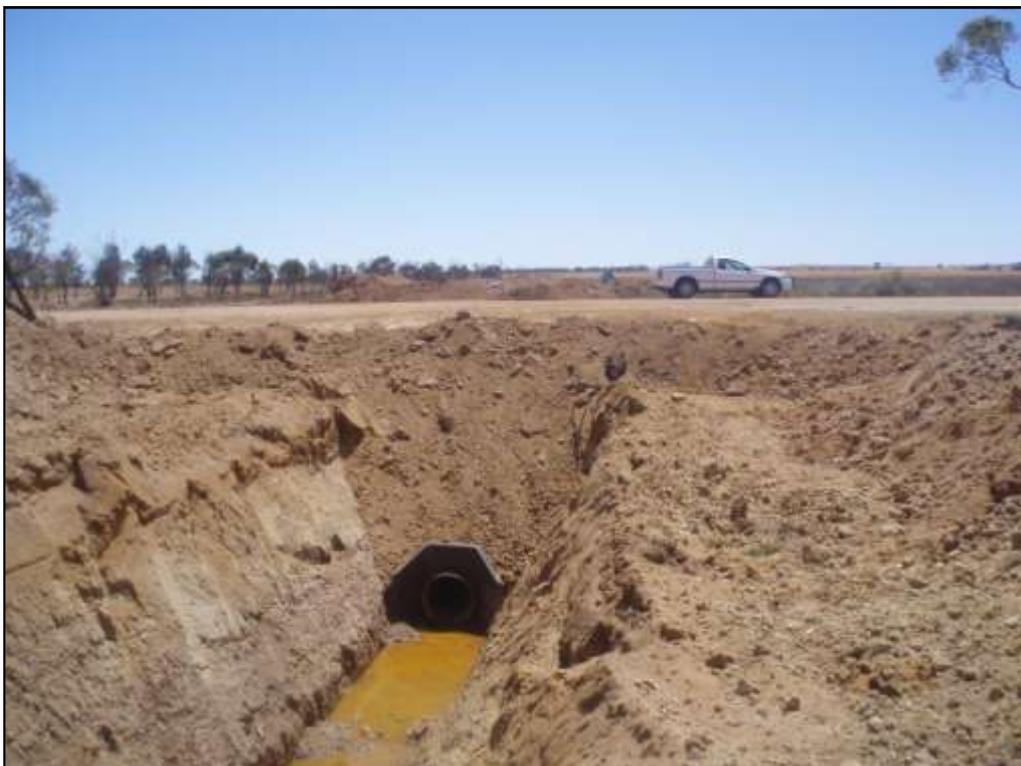
Fig 43: Wasley Road culvert

A conventional culvert passing under Wasley Road in the Jibberding drain.

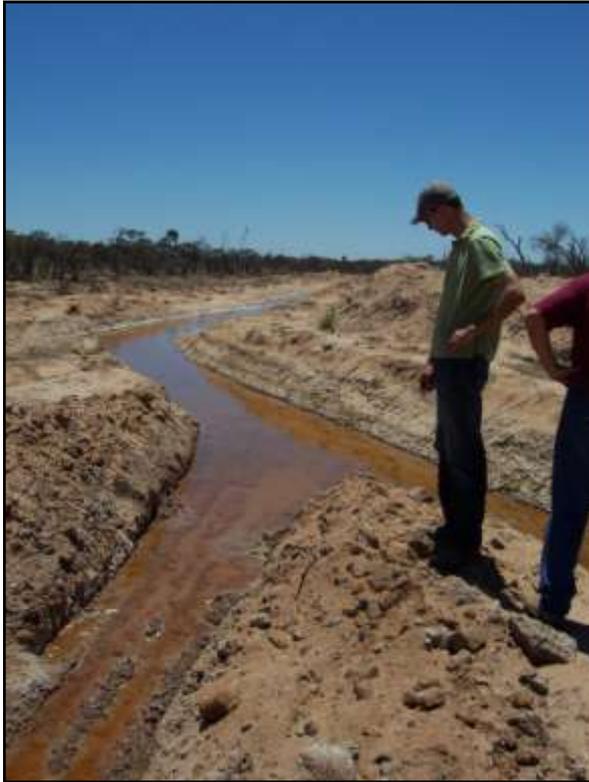
This site is the junction of two deep drains from two subcatchments; Jibberding 19 (the 2008 drain) and Jibberding 21. The drain in Jibberding 21 was established with the assistance of State Salinity Council funds, in 2003. This photo shows the two discharge points converging on a common delivery drain. Note the drains are now quite shallow as they prepare to discharge at ground level.

Fig 44: Convergence of two drains, Jibberding

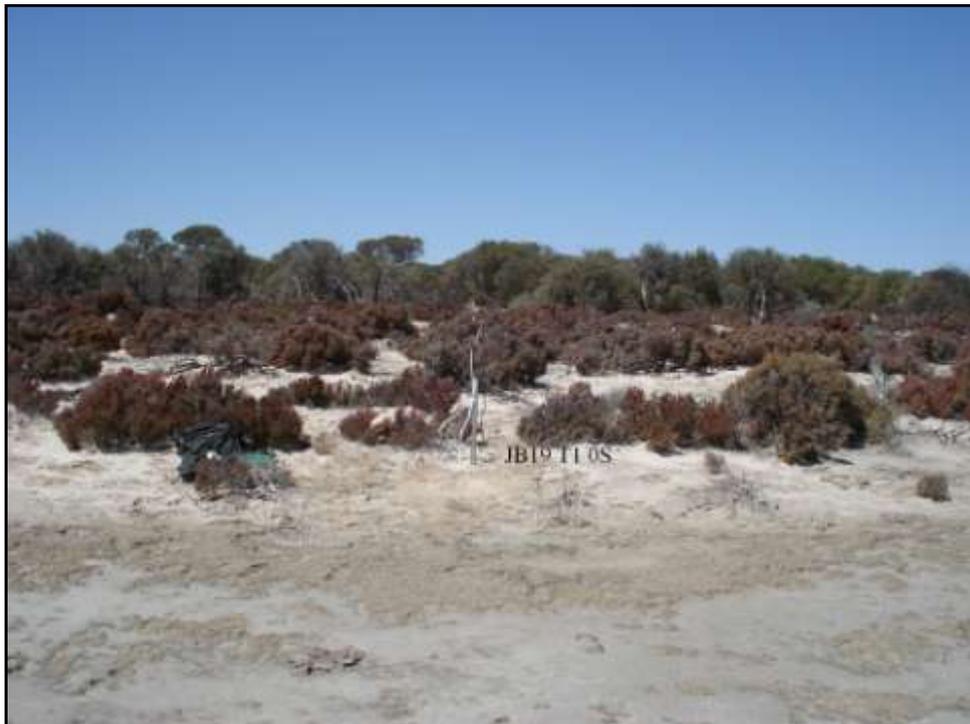
Fig 45: Jibberding vegetation survey

This shows the first transect in Jibberding (JB19, T1), one of six in the Jibberding wetland area. You can clearly see the transition in vegetation here from the edge of the lake (sand in the foreground) through the samphire flats and then into larger shrubs and trees as the distance away from the salt lake increases. The change in vegetation is an indication that the soil is also changing in texture and structure.

Vegetation transects (Figs 26 & 45), initially set up in the discharge area before drain construction as part of the baseline study, are monitored at approximately 12-month intervals. The survey uses belt transects of contiguous 10 m × 10 m quadrats, laid out in a straight line at right angles to the lakeshore or creekline. In each quadrat, all plants are identified to species or subspecies level and the vegetation structure is described (e.g. height, layering, percentage cover). There are a minimum of two transects for each discharge site (considerably more for extensive

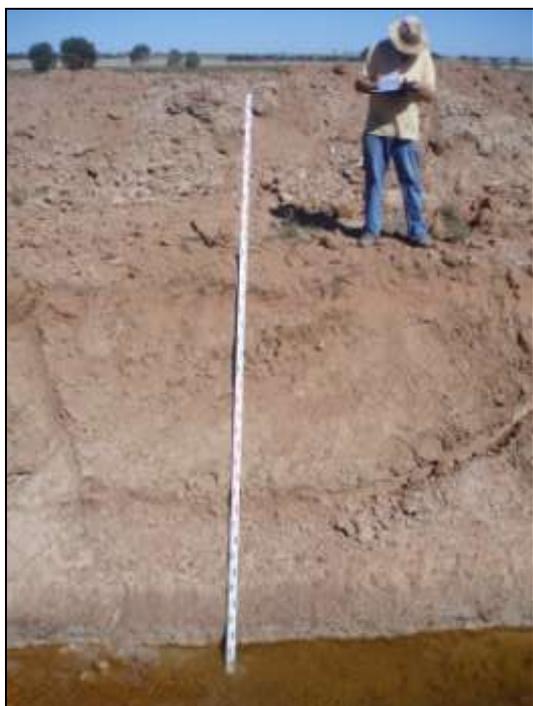
GPS readings are taken every 150 metres, photos are taken every 450 metres (Fig 48) The depth of the drain slope is measured, and from this the true depth of the drain can be calculated.

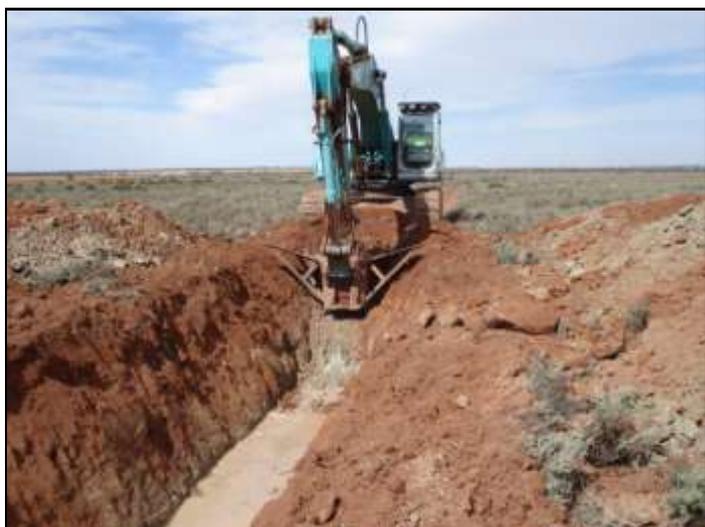
Fig 50: Excavation in Mongers 16

Length (km)	Budgeted Cost	Actual Cost
Drain Excavation	14.0 km	\$251,700.00	\$249,510
Fencing materials	23.6 km	\$48,000.00	\$44,917

Due to budget constraints one proposed spur drain of 1.5 km was abandoned initially reducing excavation costs. However additional cost were incurred by the Department of Environment insisting on three extra crossings for wild life and a flattening of the batter on one 900 metre section of drain at an extra cost of \$25,000. We strongly believe that this was an unwarranted use of public funds.

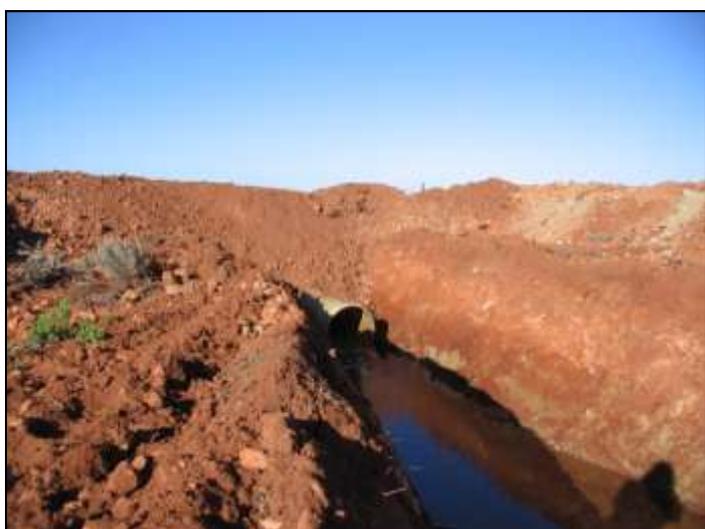
Fig 51: Culvert under Simpson Road, Mongers 16

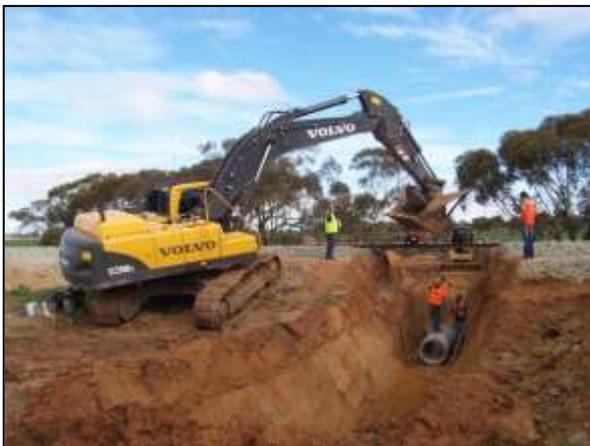
Fig 53: Installing the under rail crossing at Burakin

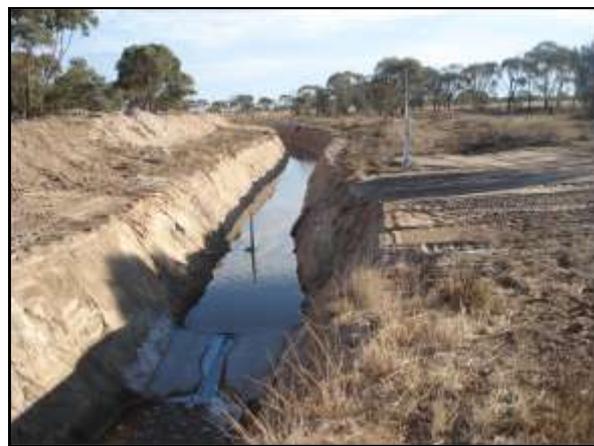
Fig 54: The crump weir. The design of the weir prevents silt deposition here.

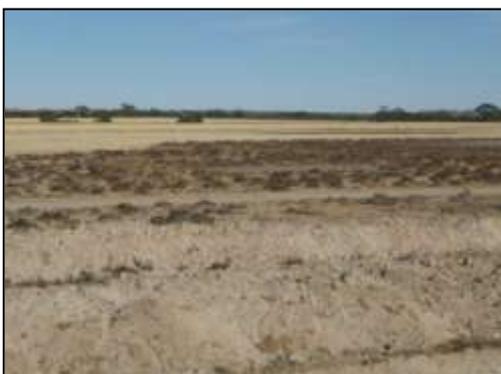
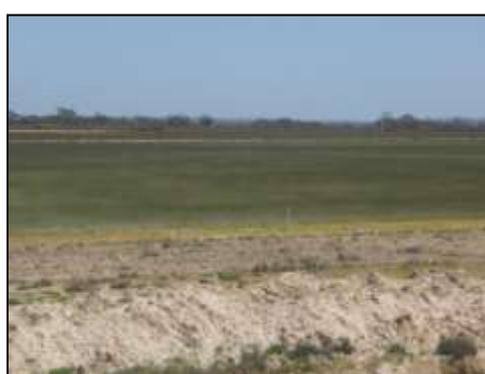
Figs 55a and 55b: Before and After

The Burakin drain has been very successful with spectacular crop establishment on reclaimed land within the first year.

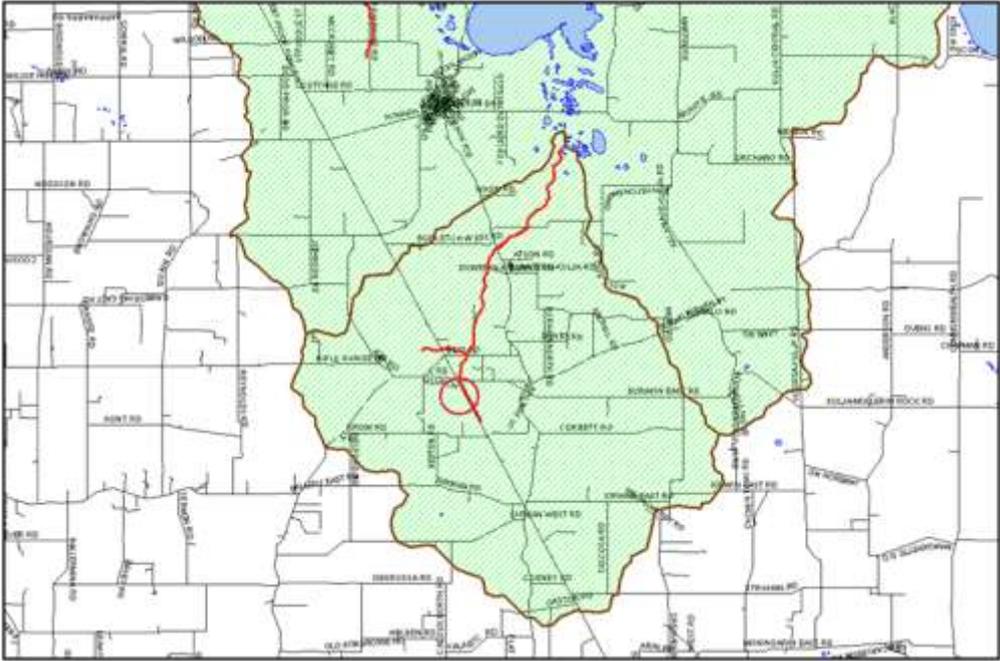
Fig 56.

The red line marked on the map above represents the constructed arterial drain. The circle near the beginning of the drain is a reference point for Fig 57 below. The photo shows a degraded area which is 14 km from the discharge point (which is a small lake on the periphery of Lake Hillman to the North). Water tables at the reference point were within 1.2 metres of the surface at the time of drain construction. The importance of this demonstration is that the drain passes through 5 properties on its way to the lake. Without this public facility then 4 of these farmers would not be able to safely deliver saline ground water out of their farms.

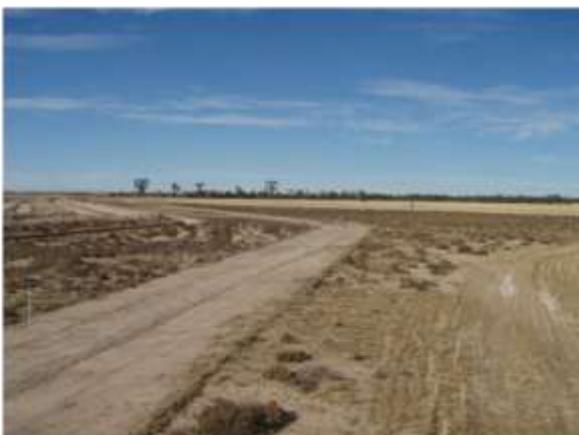
The photos below were taken about 500 metres south of the bore transect. Fig 59a on the left was taken just prior to seeding, the ground cover is samphire. These flats have not supported any other vegetation for around 10 years. This barley crop was planted 10 months after the drain was constructed.

Note the Salmon Gum trees in the background which are a reference point for the photos

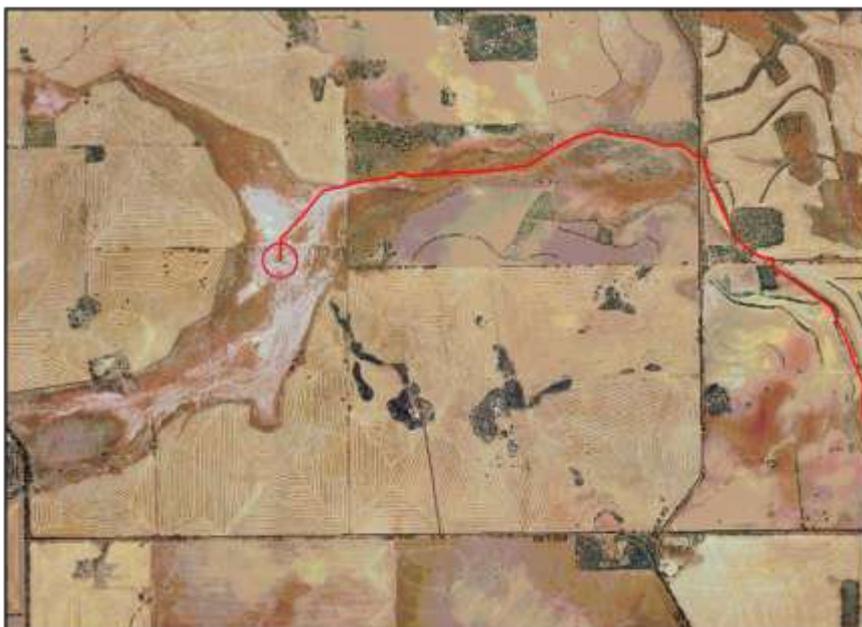
Fig 62

The circle to the left is a reference point for the extensive salt scald shown in the aerial photo below (fig 62), which is at the beginning of the Merkanooka drain. The arterial drain allows this area to be drained to the discharge point 25km to the south.
