## **A Flora and Vegetation Survey for Clearing Permit 1969/1 (Mongers 16)**

Clearing Permit 1969/1 was issued to the Yarra Yarra Catchment Management Group (YYCMG) on 15/3/08 for the proposed drain, Mongers16. The Department of Environment & Conservation (DEC) expressed particular concern about two areas, which they identified in their accompanying maps 1969/1b and 1969/1c. In the Decision Report (their Item 3c), they name six threatened plant taxa reported from sites within 20 km of the proposed works, viz. *Acacia lineolata* subsp. *multilineata* (P1), *Acacia nigripilosa* subsp. *latifolia* (P1), *Darwinia* sp. Carnamah (DRF), *Eremophila rostrata* (DRF), *Gnephosis setifolia* (P1), and *Wurmbea murchisoniana* (P4). There was an explicit requirement (Condition 4) that a search for these plants be carried out by a 'flora specialist' prior to any clearing in the two areas of concern.

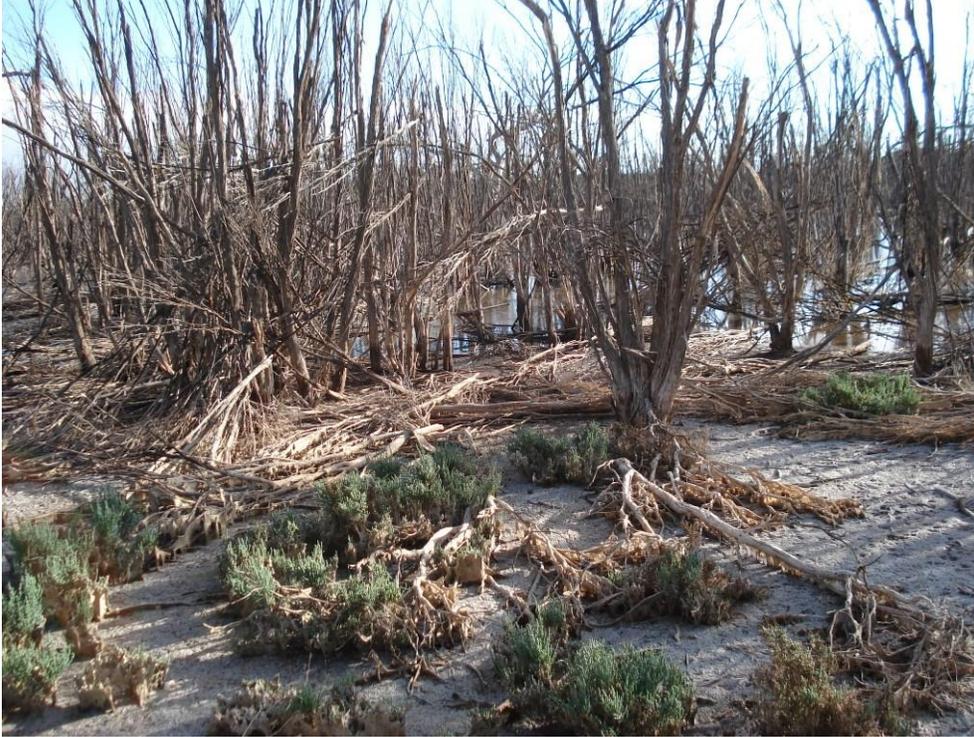
The 1969/1c area, north of Taylor Rd, is particularly degraded. There, the proposed drain runs along the margin of a poorly drained claypan, with the remains of a melaleuca forest, where 100% of the trees (probably mostly the paperbark *Melaleuca eleuterostachya*) are now dead (Fig. 1). There is a very simple samphire community, overwhelmingly dominated by the single species *Tecticornia pergranulata*.

Fig. 1. Saline claypan, with paperbark forest being replaced by samphire shrubland.

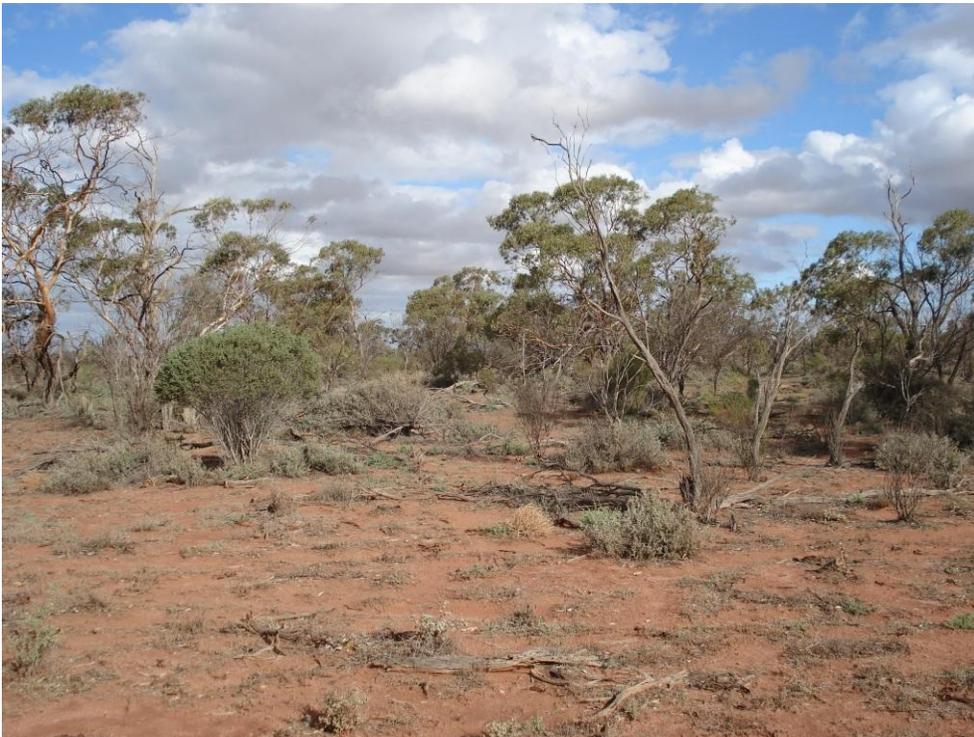
The proposed drainline skirts this waterlogged area and passes through a York gum woodland. This woodland too is degraded – although not as severely as the adjacent saline swamp. About half of the canopy gums are dead, and most of the remainder are defoliated to some extent (Fig. 2).

Fig. 2. York gum open woodland.

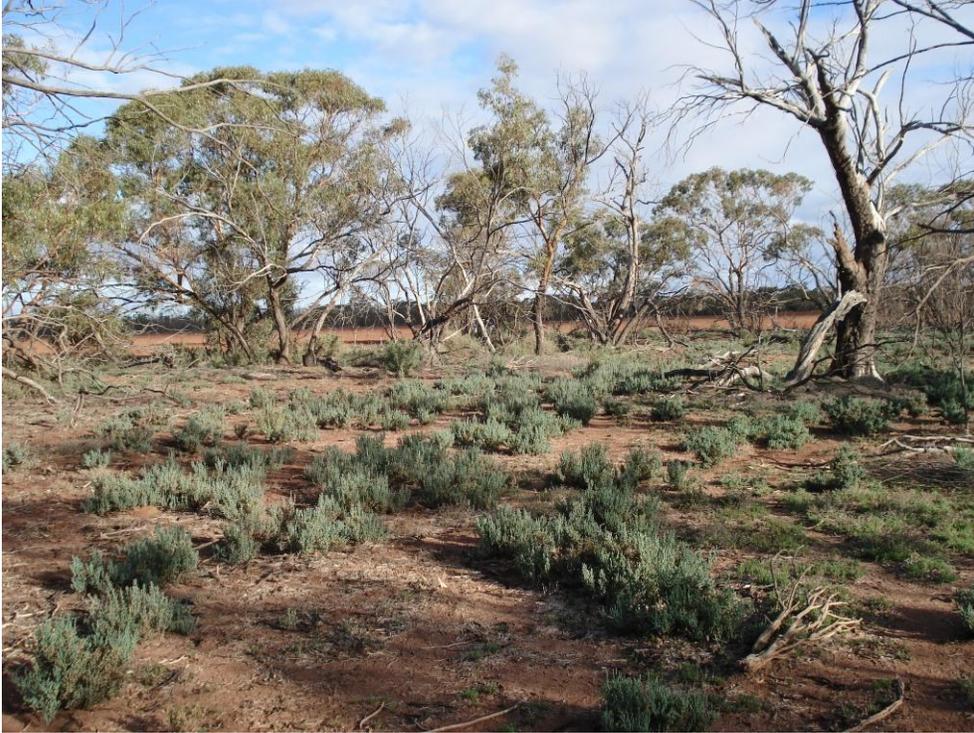
Along the margin of the bush area, i.e. at the paddock edge, is a single row of York gums in apparently excellent condition (Fig. 3) The trees here are taller and more frequently single-stemmed, the trunks are broader, the lowermost canopy tends to be further from the ground, and the foliage is more lush. The canopy cover of this boundary unit may exceed 30%; overall cover for the entire woodland is less than 5%.

Fig. 3. Line of 'healthy' York gums at the woodland-paddock boundary.

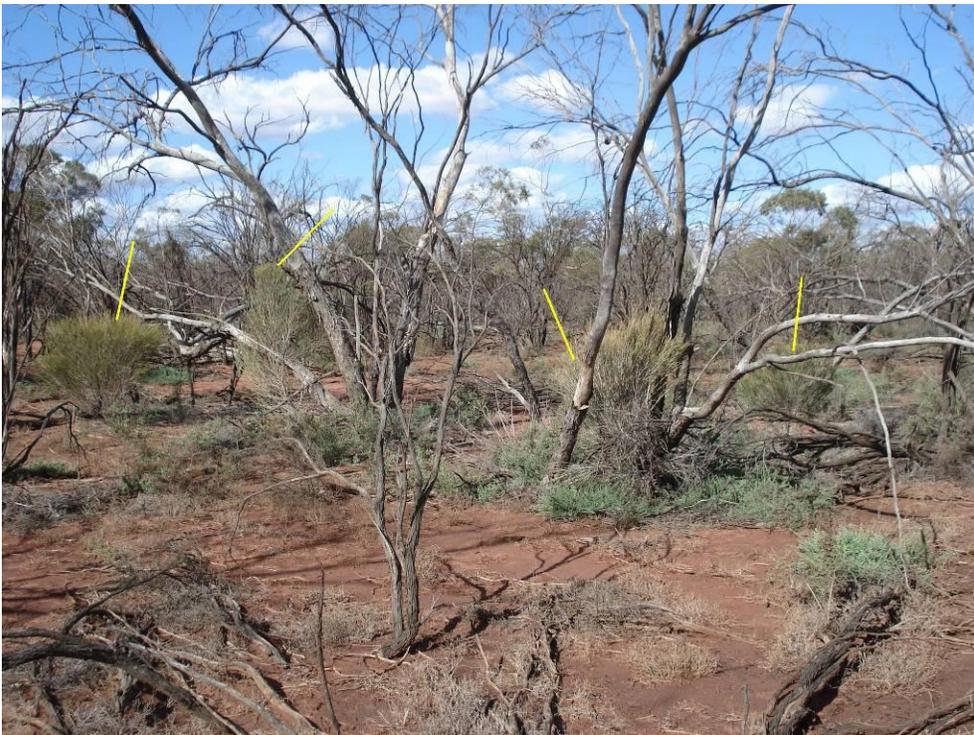
The large (approx. 100 ha) bush block south of Taylor Rd is also predominantly a York gum woodland. There are patches of melaleuca scrub throughout. Many of these are roughly circular and coincide with obvious claypans; others are less well-defined, and merge imperceptibly with woodland (Fig. 4). The entire southeastern corner of the block,

Fig. 4. Cluster of broombushes (*Melaleuca atroviridis* – indicated by yellow lines).

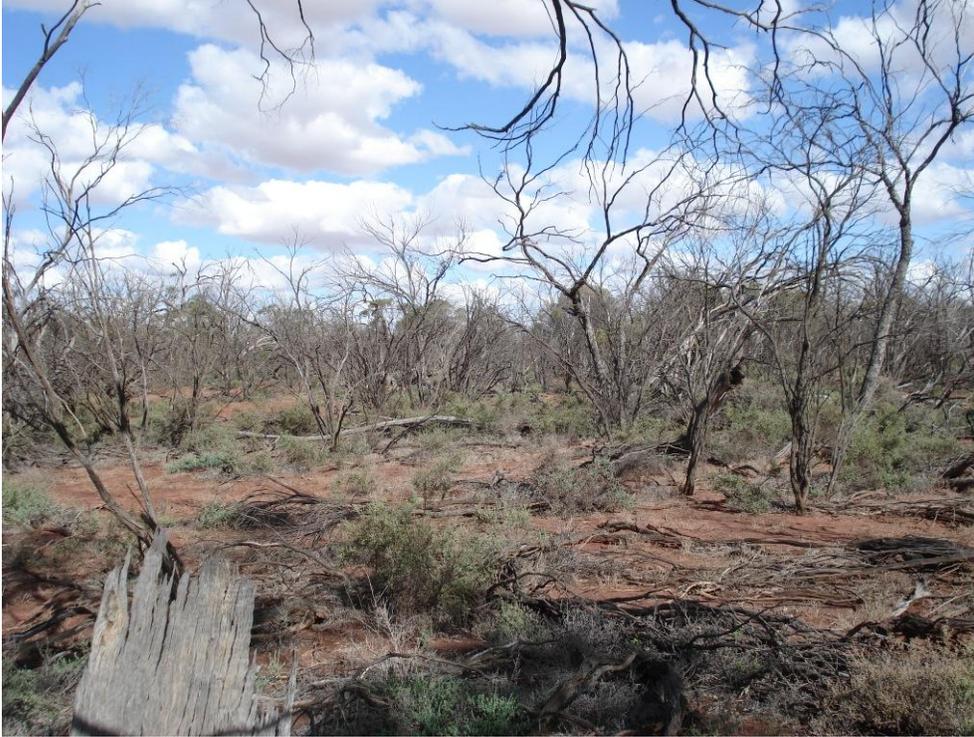
Along the entire length of the proposed drain, the vegetation is in poor condition. At the northern end (near Taylor Rd), only one canopy tree in four retains any foliage at all (Fig. 5). This high degree of degradation declines gradually southwards, so that at the southern edge of the bush block, only one canopy tree in two appears dead (Fig. 6).

Fig. 5. Severely degraded York gum woodland near the northern (Taylor Rd) boundary.

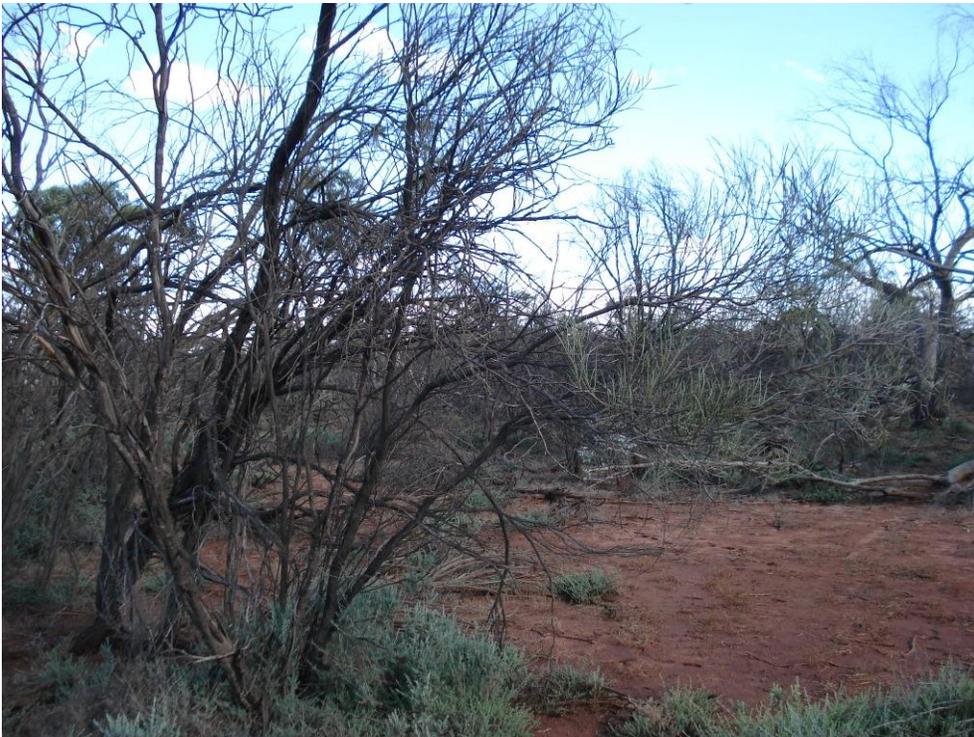
Fig. 6. Degraded York gum woodland near the southern boundary. Note that ground now exposed by the decline in foliage cover is being colonised by chenopod subshrubs.

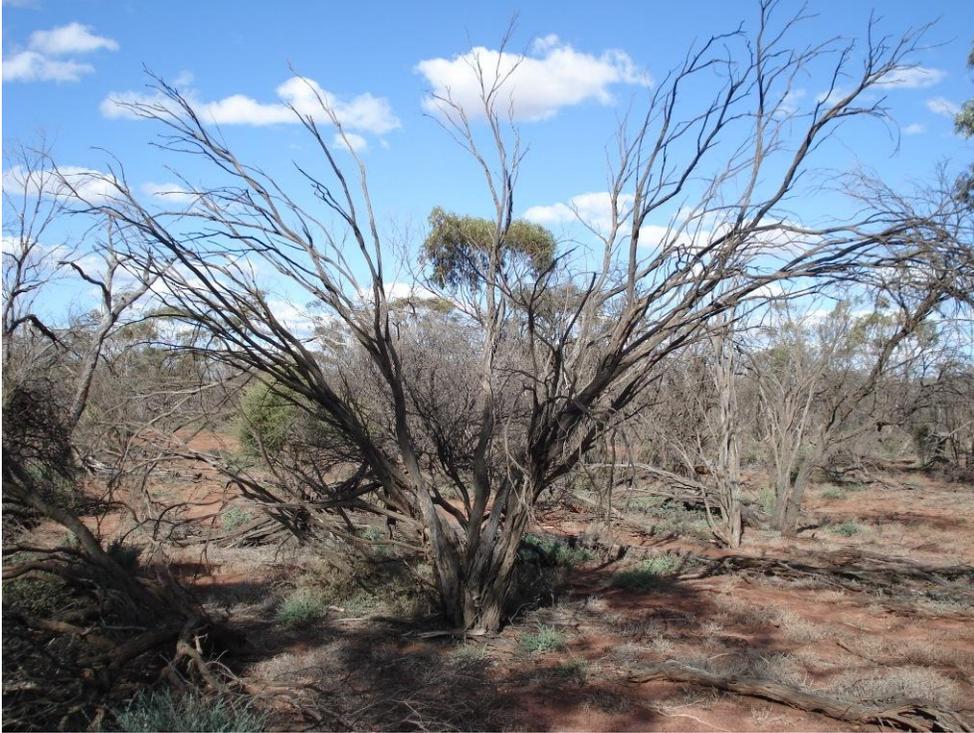
Except for a few isolated shrubs and small trees, the midstorey is entirely dead. It is represented now by standing deadwood – probably acacias for the most part (Fig. 7). The live exceptions, encountered only rarely, include *Senna charlesiana*, *Eremophila oppositifolia*, *E. decipiens*, *Dodonaea viscosa*, *Acacia colletioides*, *Scaevola spinescens* and *Exocarpos aphyllus*.

Fig. 7. A dead midstorey tree/shrub – probably an acacia.

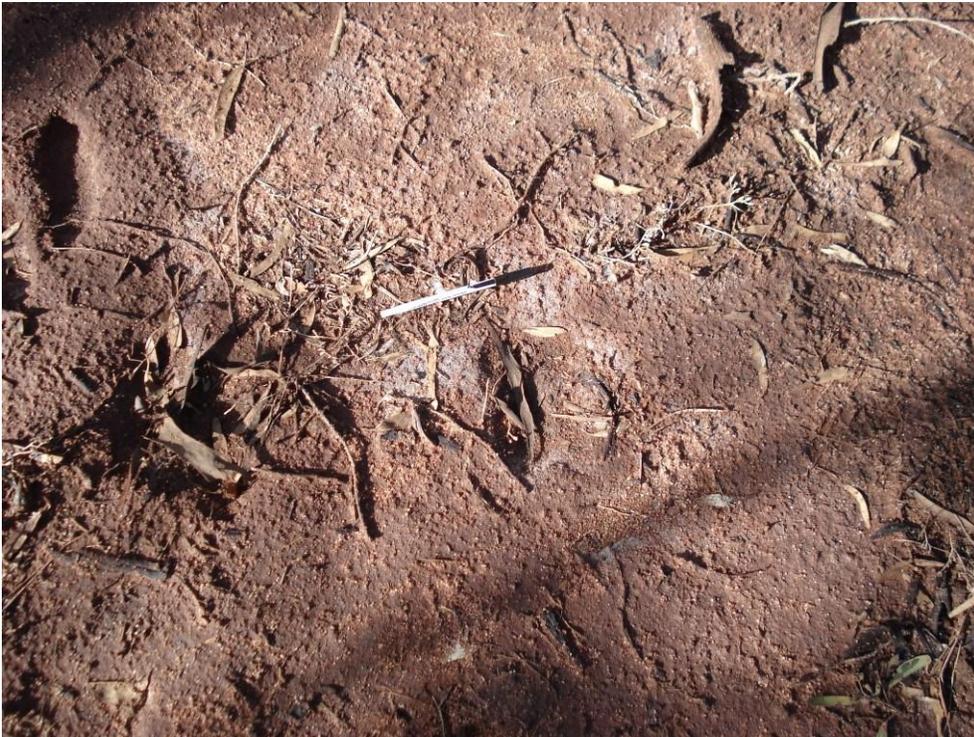
The substrate varies from reddish yellow to yellowish red to reddish brown. It is a loamy sand near the northern margin. Clay content increases unevenly across the block from north to south, so that the soil near the southern boundary is a sandy loam. There are small patches of white salt efflorescence throughout the woodland (Fig. 8).

Fig. 8. White salt-efflorescence patches are common on the woodland floor.
